Replacing the Diode Pack on a Denso Discovery 3 Alternator

99.9% of the time the only thing stopping a Denso Alternator from charging is the diode pack, you can purchase the pack and replace it in about 1 hours time with the Alternator removed.

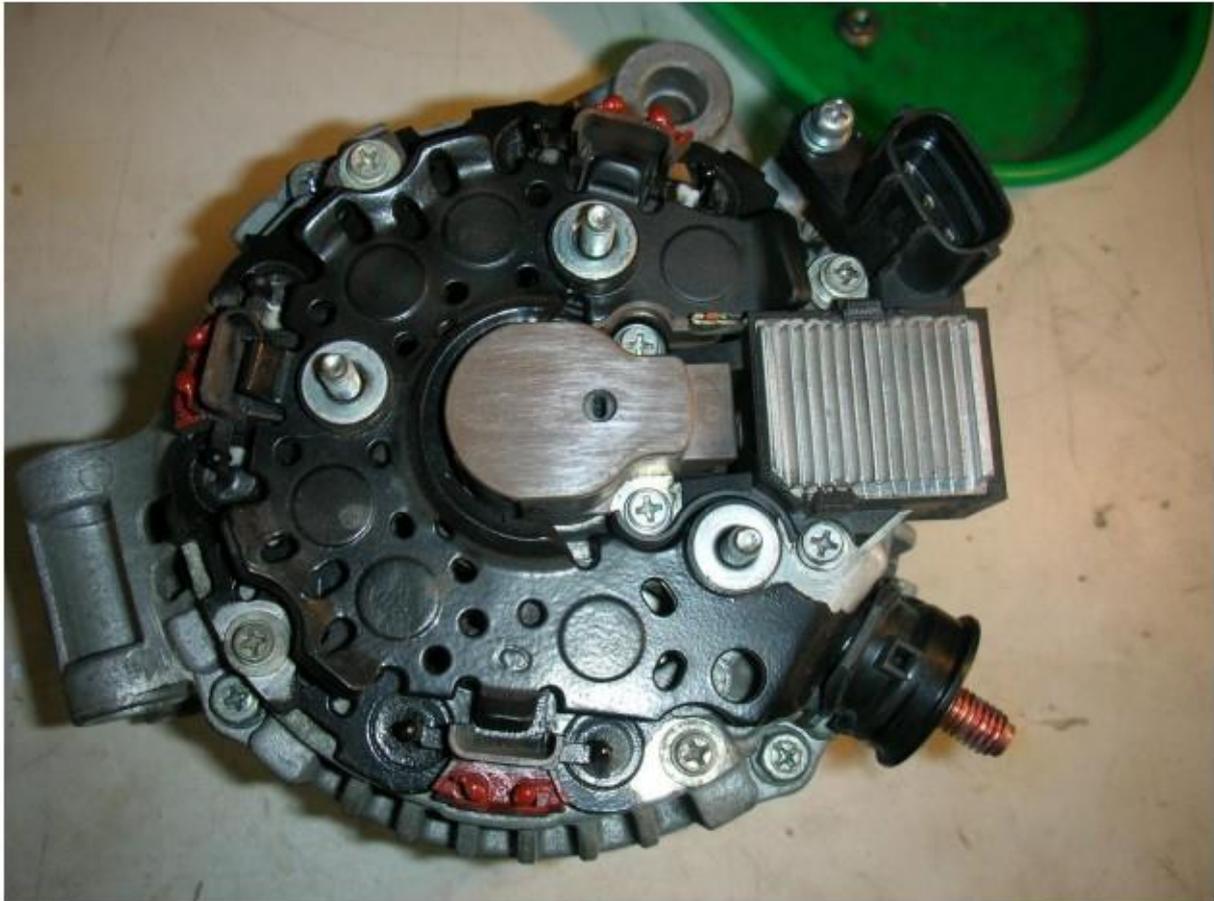
Ok first thing to remove is the black plastic cover on the rear by removing the three 8mm nut's holding the cover in place.

You should see this view now exposing the diode pack base plate.

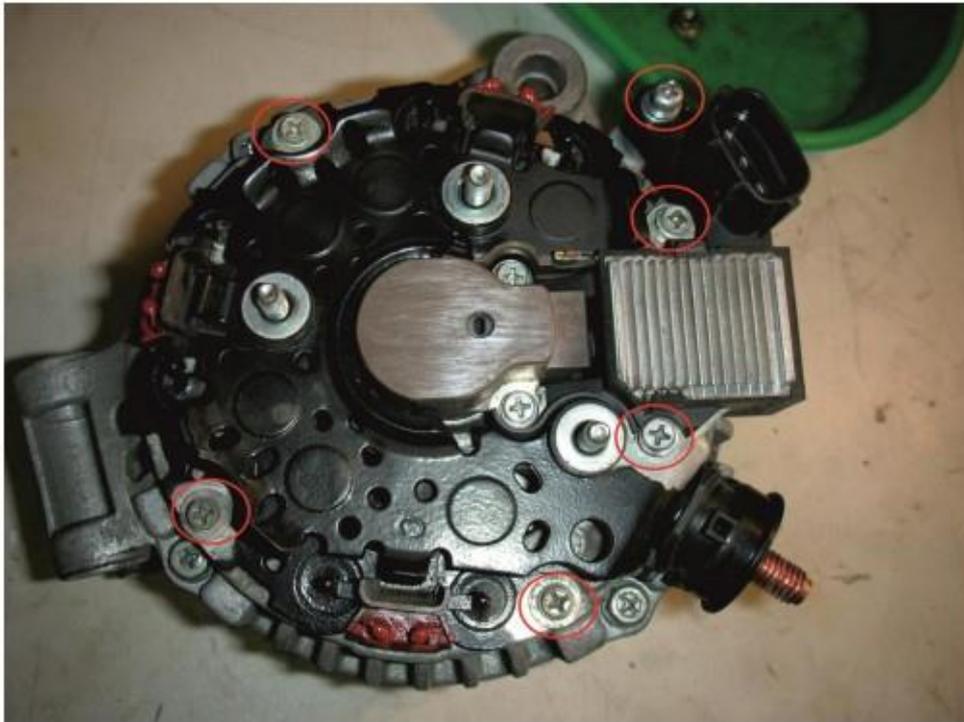
Now remove the two screws holding the brown carbon brush holder in the centre of the unit, then just lift it off and put it somewhere safe out of the way.

Now remove the six screws that are ringed in the picture below.

Once removed store in safe place. Also remove the black plastic bobbin on the main battery lead terminal and store in a safe place.

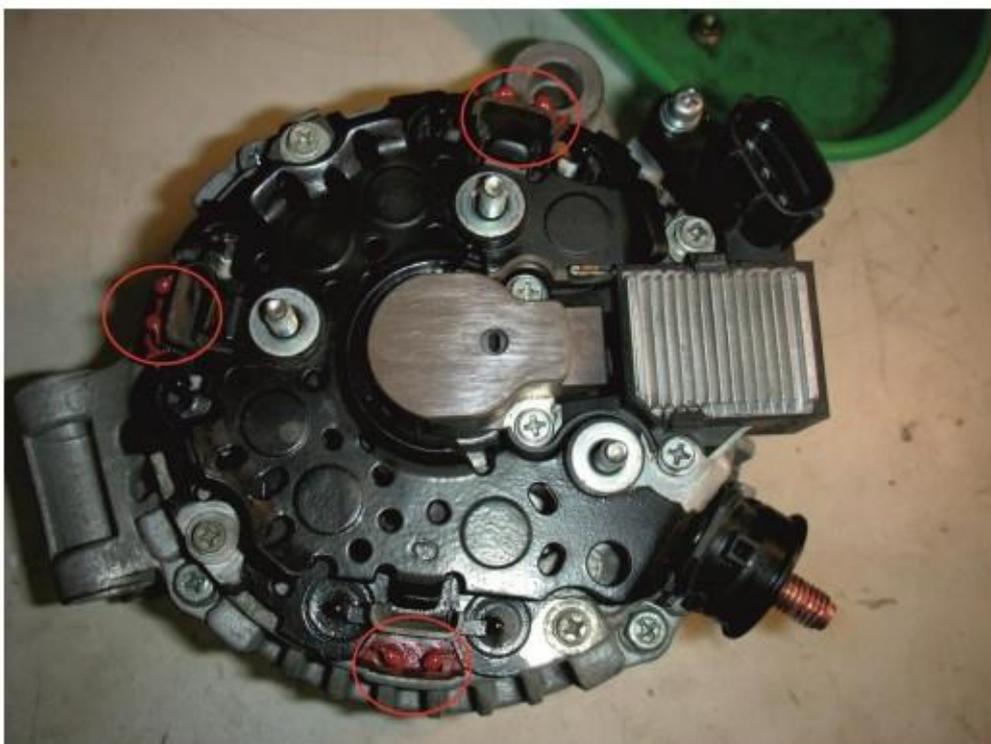
Now comes the tricky bit you need to remove the solder from the 3 places ringed below this is the hard solder so it takes some melting, So instead of trying to melt it just use a dremmel and cut the wires as close to the top of copper guides, a lot easier then trying to melt the industrial solder.

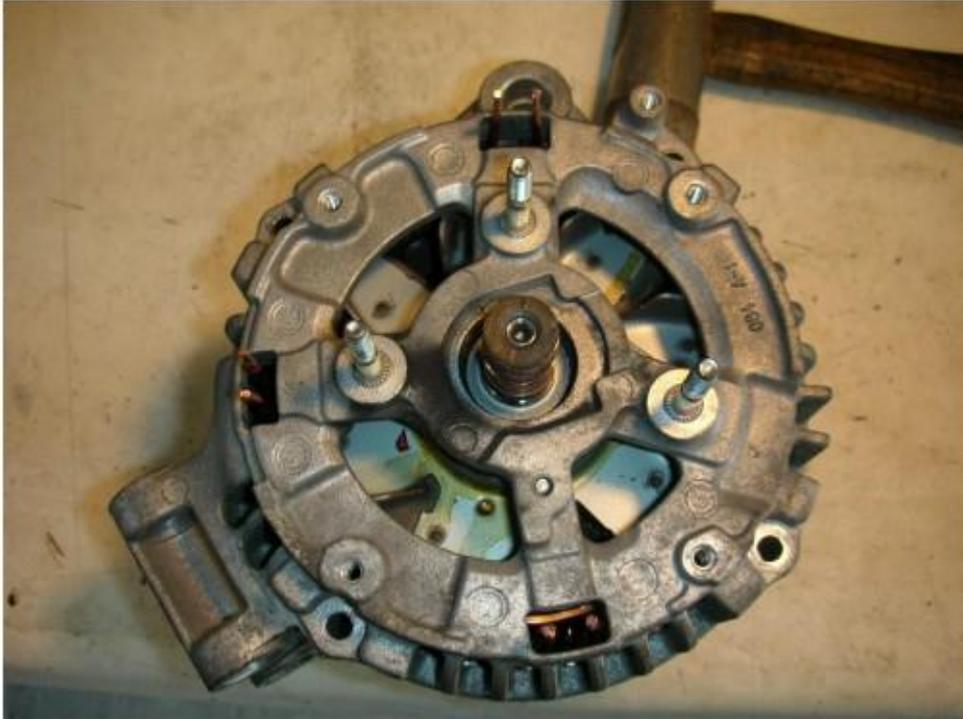
Once you have removed the solder you can now remove the diode pack from the main body of the alternator by lifting it off the three studs, you should now have this view.

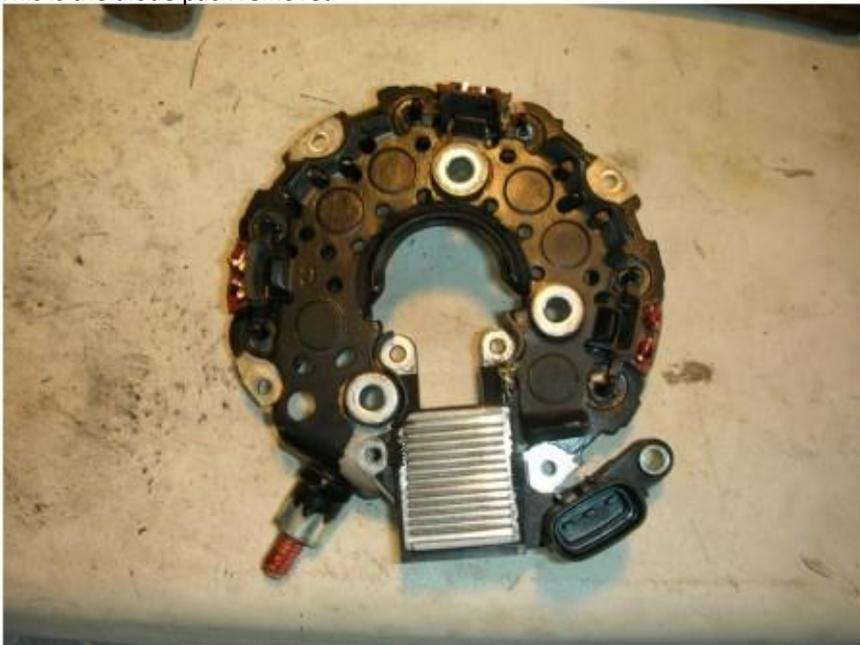
This is the diode pack removed

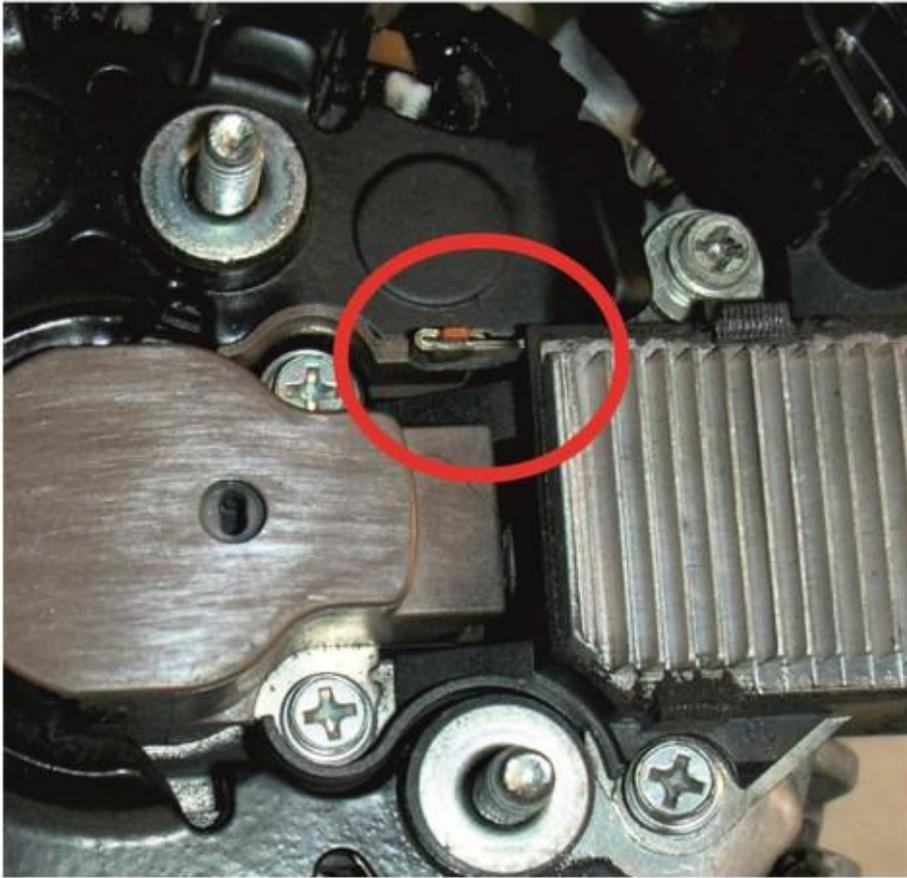
You now need to remove the silver vaned rectifier by removing the solder from the connection from the copper tag, this needs to be re-soldered on to the new diode pack.

See Picture below.

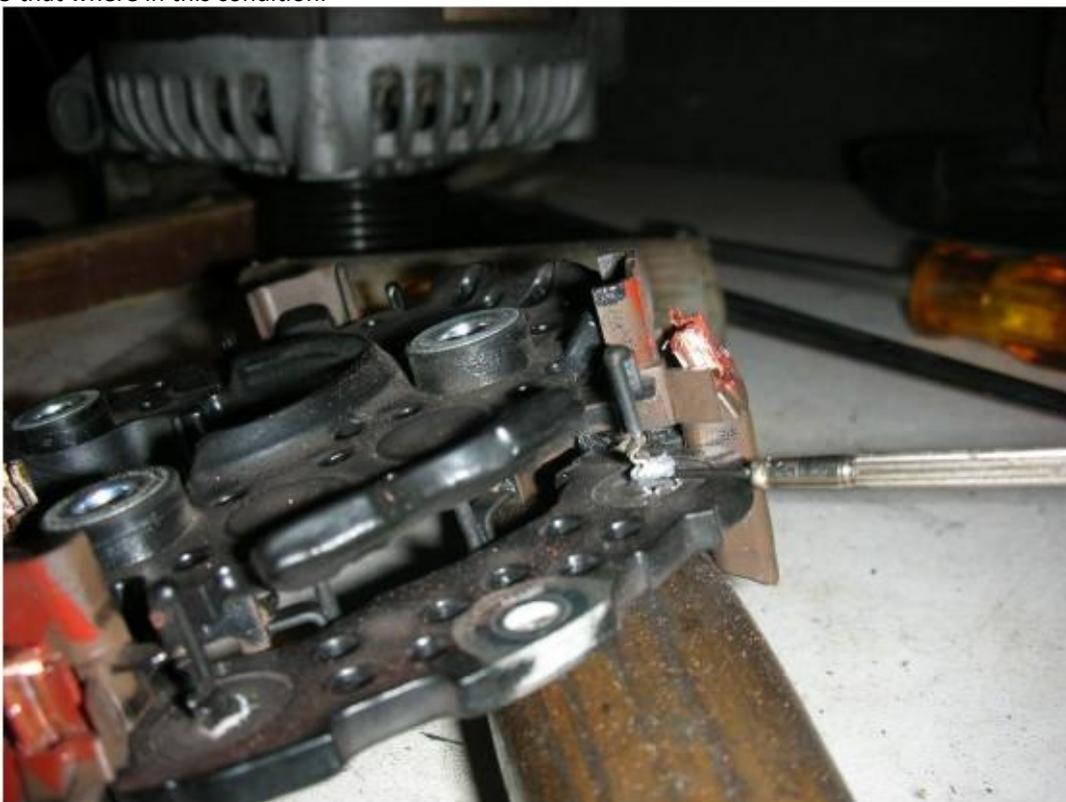
As you can see in the picture below there are two diodes that have blown apart there was a total of 5 that were in this condition.

There is no way of testing the alternators until its back on the car as its controlled by the cars ecu, but like I said it is always the diodes that fail.

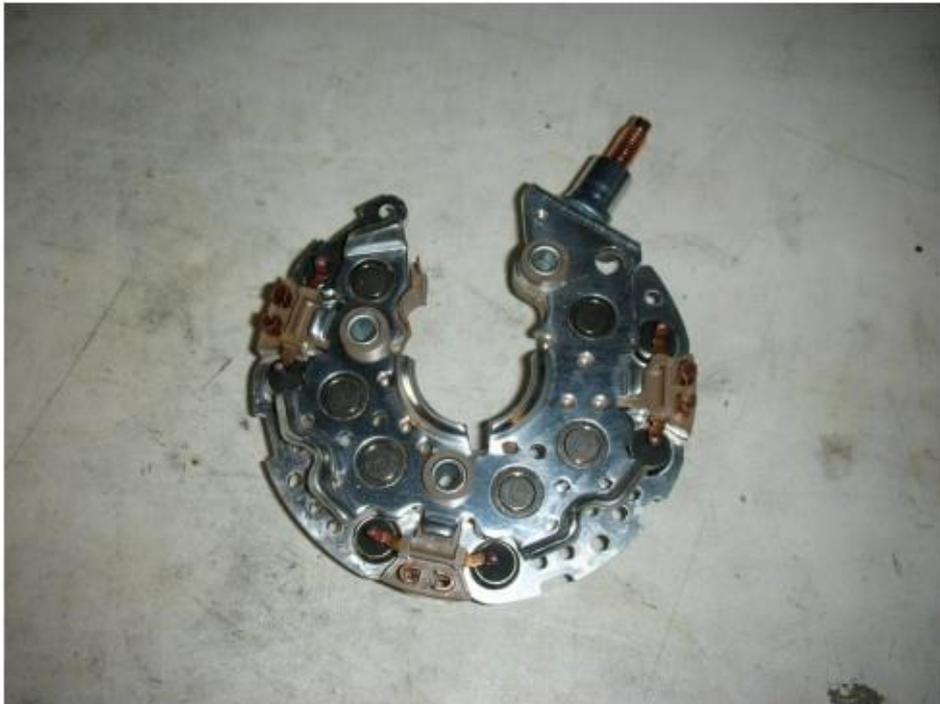
Ok now to refit the new diode pack.

Slide the new diode pack over the three studs making sure the six copper wires come through in to the three connectors that you will now re-solder back on to the diode base plate.

Replace the four main screws holding the diode base plate to the alternator body to make sure its fully down before re-soldering the three connections. Solder the three connections, use some flux on the copper wires to make sure you have good joints.

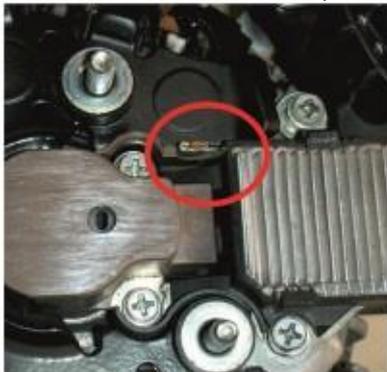
Now refit the silver vaned rectifier with the other two screws and re-solder the copper tag in the centre of the unit. See below picture.

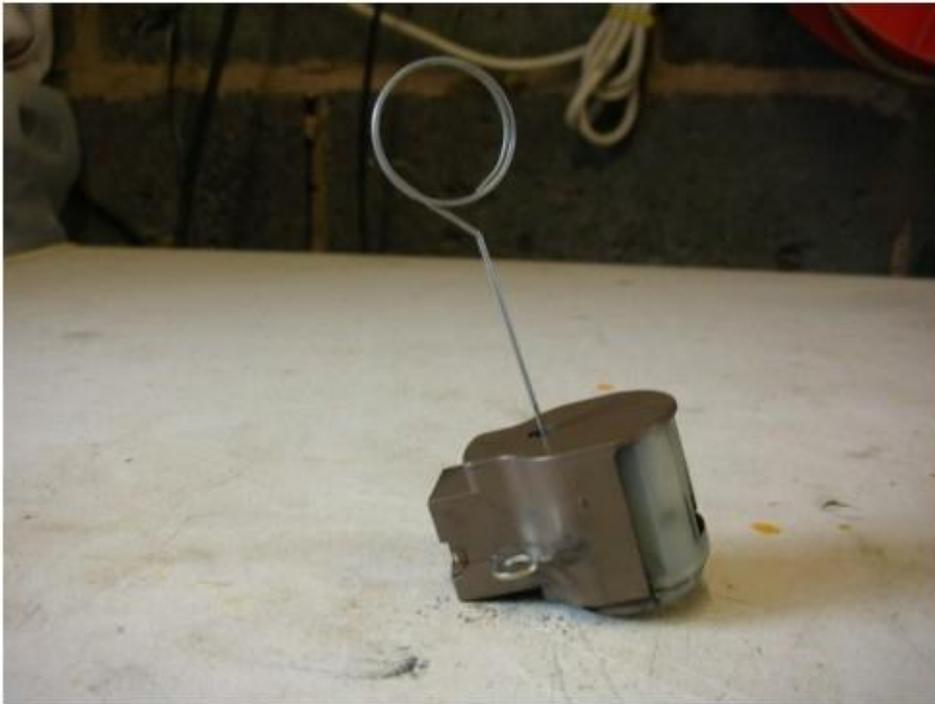
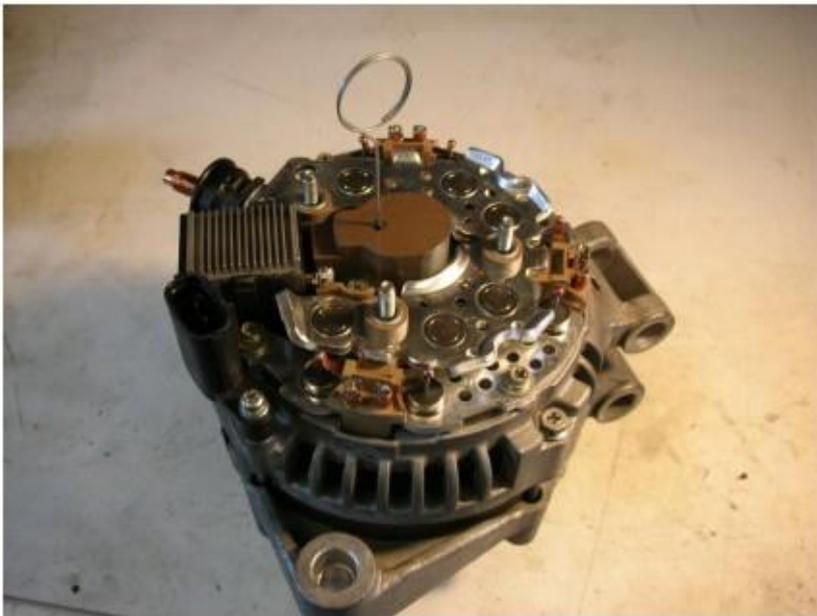
Now this is where you need the small pin to keep the brushes in the fitting position while you refit the brushes holder.

See picture below.

This is the view of the holder with the pin in position ready to fit.

Slide the holder back on to the main shaft and secure using the two screws then once all secure pull out the pin and you should here the brushes click against the main shaft.

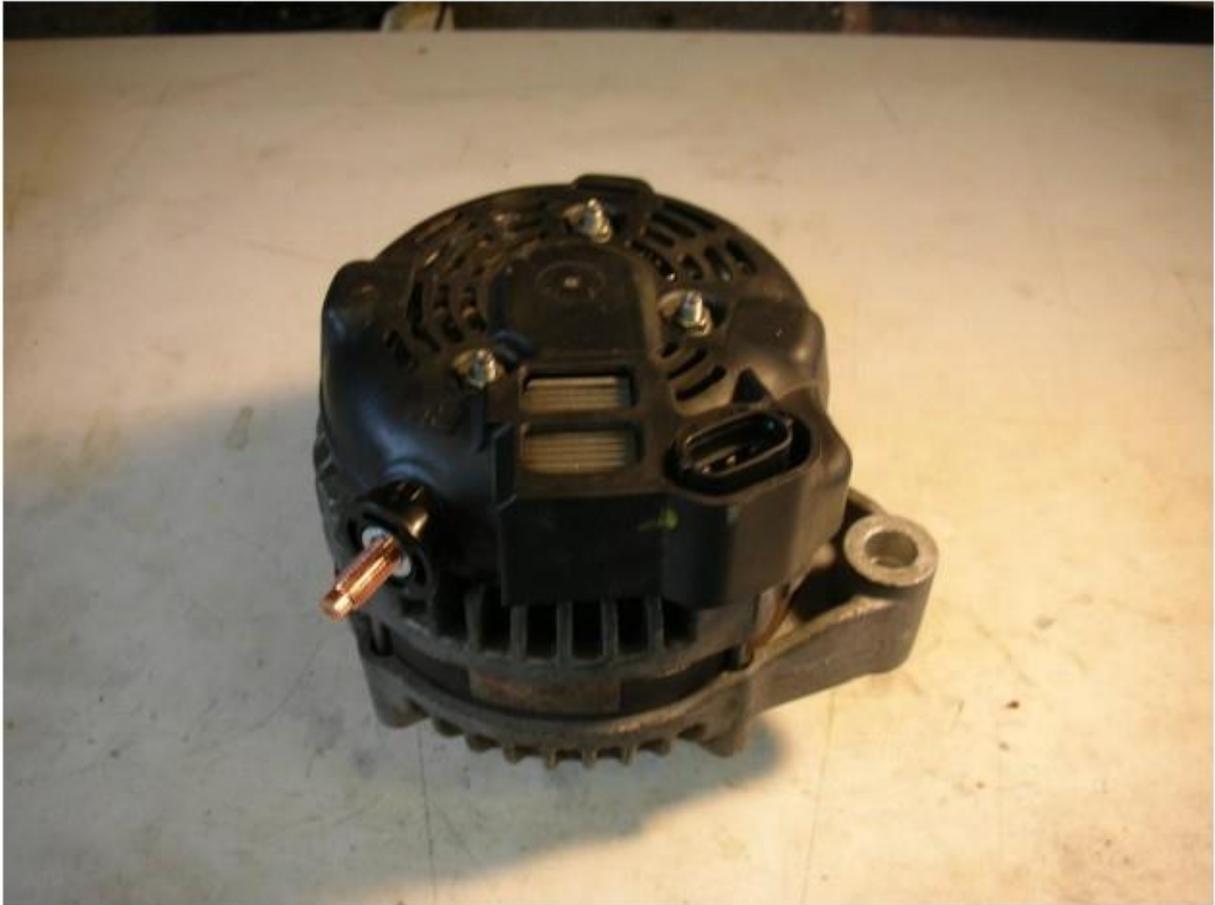
When its all back together it should look like this.
